Bulletin Number: SB-0002

Appliance Model: NS-TWM41WH8A

Subject: Defect with the bolts

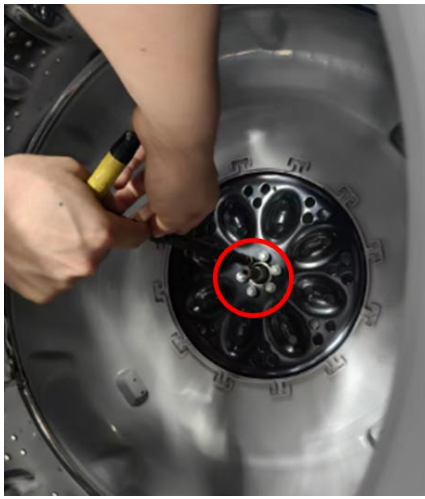
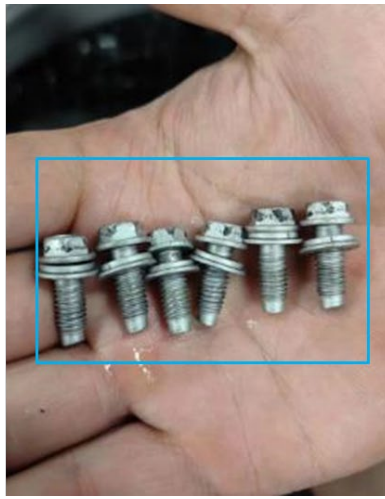
- Tub will not spin.
- Broken bolts will be found.
- Tub out of balance.
- Grinding noise during rotation

This should not affect the surrounding plastic tub or create water leaks. Below are pictures of the location and bolts. There are 6 bolts and they are located under the agitator.

If during a service repair you identify that one or more of these bolts have broken, **DO NOT REPAIR** the unit. Follow SOPs to replace/exchange the unit.
